# Seawall Maintenance & Repair 2016 CIWHA Annual Meeting

Eric Newman, PE – TranSystems  
Waterfront Civil Engineer

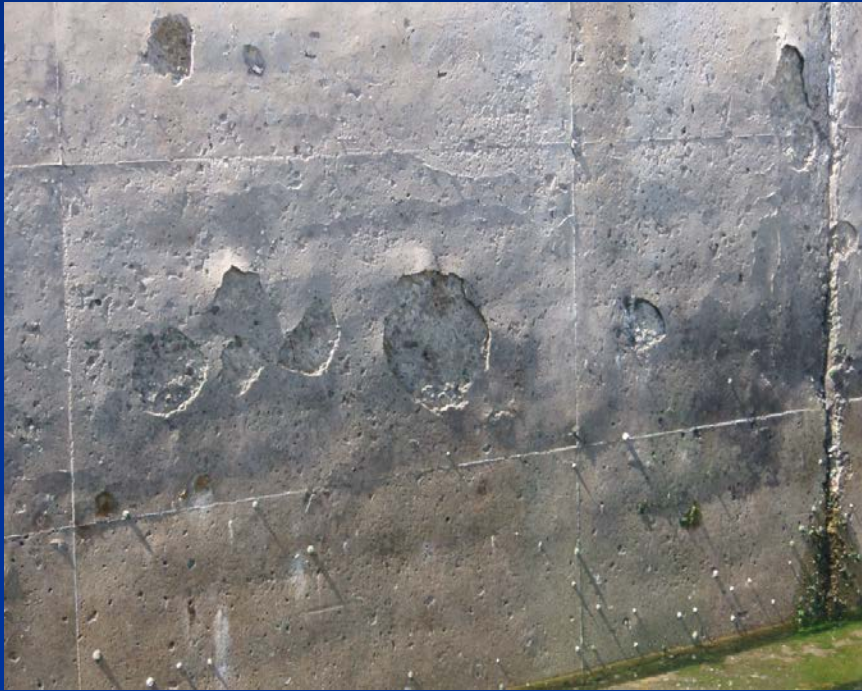
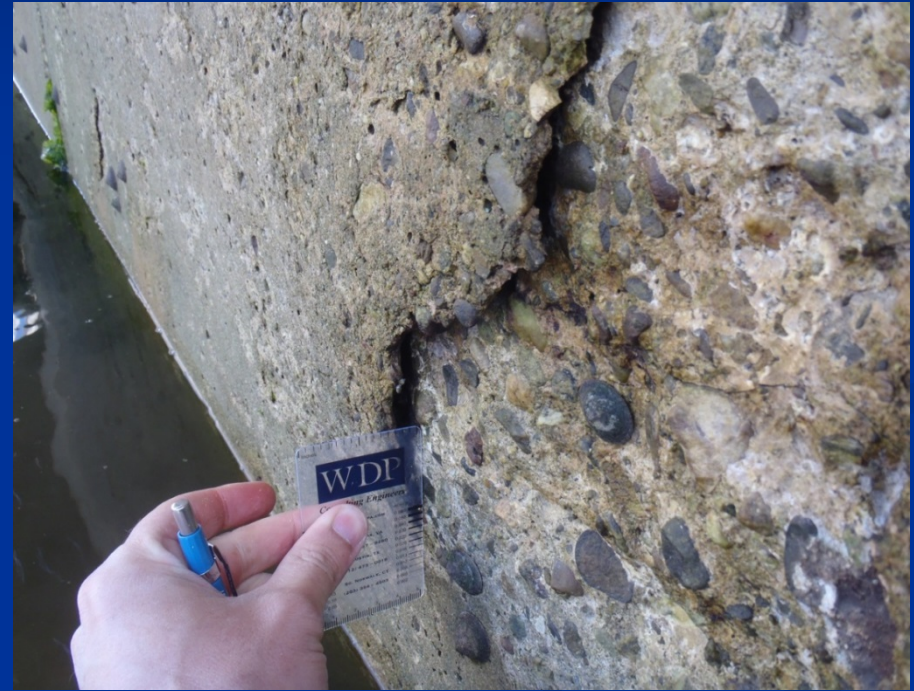
# Exterior Surface Condition

- Seawall Scaling/Erosion is due to an expansive reaction called Alkali-Silica Reactivity. The damage depth ranges from 0-4” and varies dramatically by environmental exposure/wall orientation.
- This chemical damage is worse on the Zurn walls but a concern for both wall types since the steel reinforcing is close to the surface of the Boise walls.
- Failures are anticipated to start occurring in 2 to 5 years which will quadruple the repair cost if each block is dealt with on a small scale “emergency repair” basis.
- Existing Pilaster Jacket repairs are performing well but additional jackets are needed in a timely manner to avoid high cost repairs.
- Existing underwater Vinyl Sheet Pile repairs at the wall corners are performing well to prevent further undermining

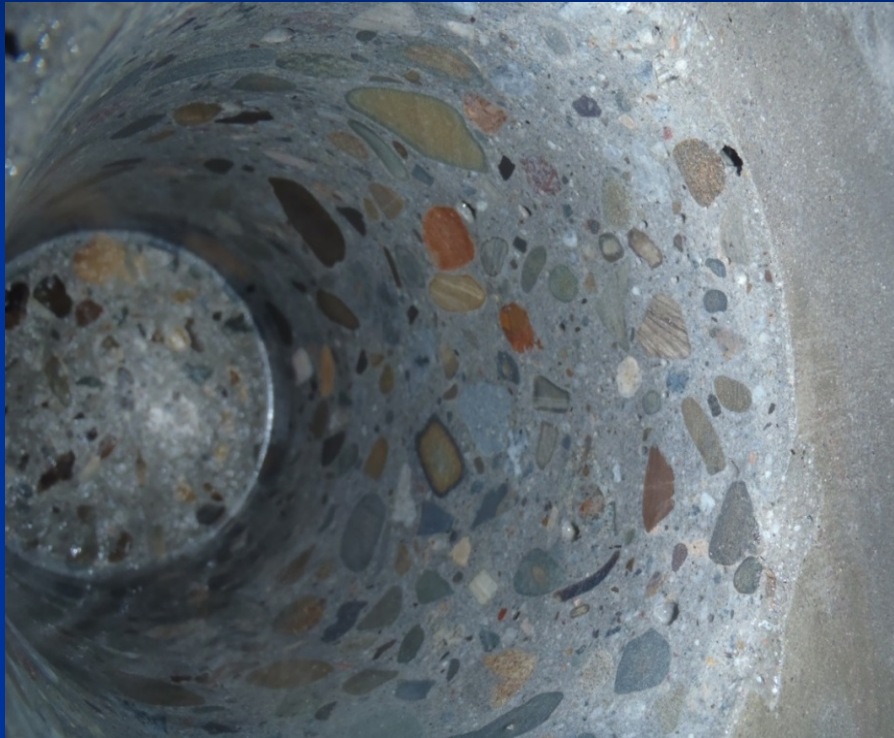
Good Condition

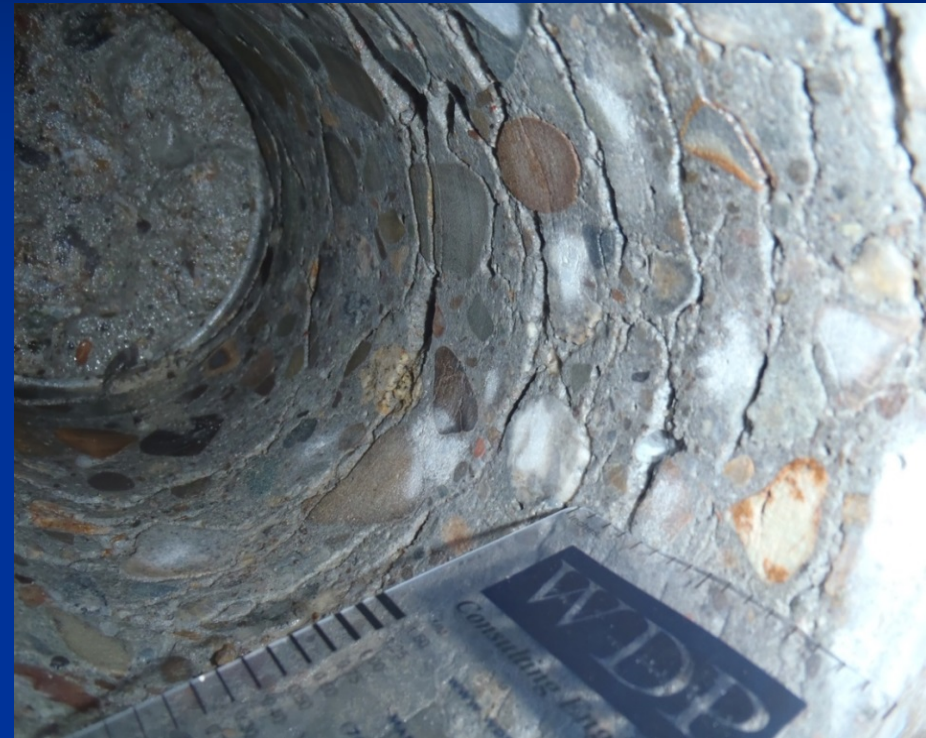
Poor Condition
