# Public Works Department Streets & Waterways Division

## *Mandalay Bay Annual Report*

*Presented by*  
**Raymond Williams**  
**Construction & Maintenance Manager**

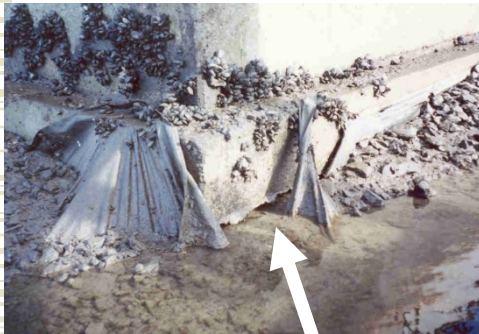
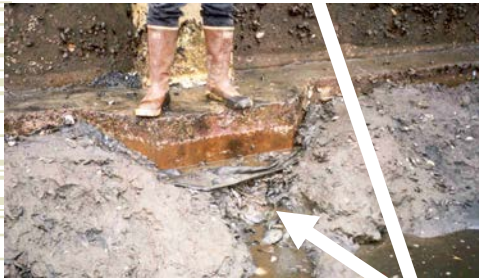
Bottom of foundation slab exposed

Hump in Fabriform slope protection

Repair foundation area with polyvinyl sheet pile cutoff wall with concrete seal

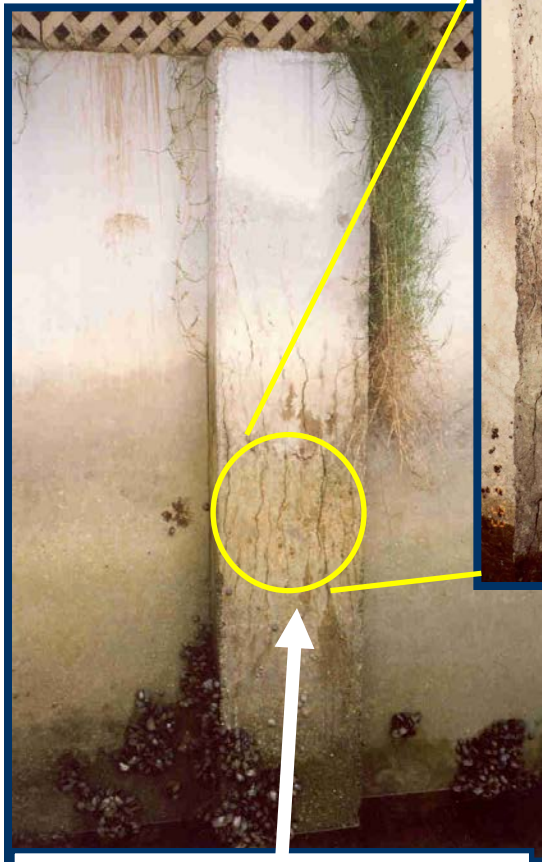
Typical deterioration

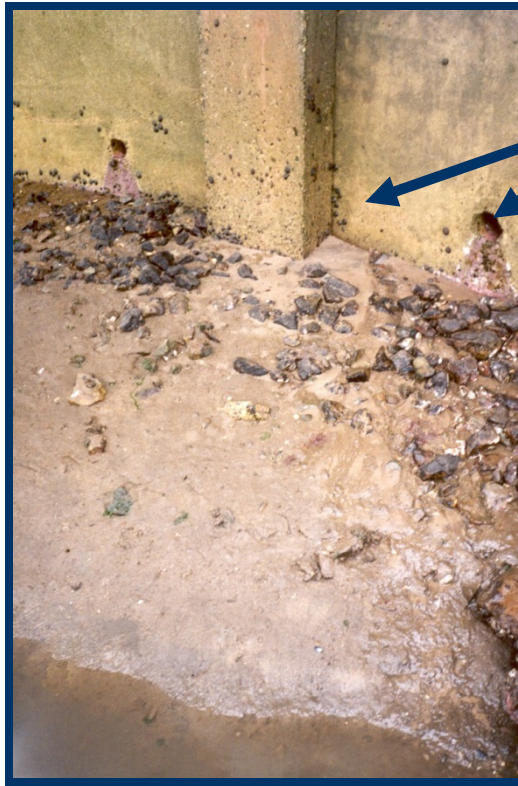
Backfill leaks from weep hole and gap between pilaster and wall panel

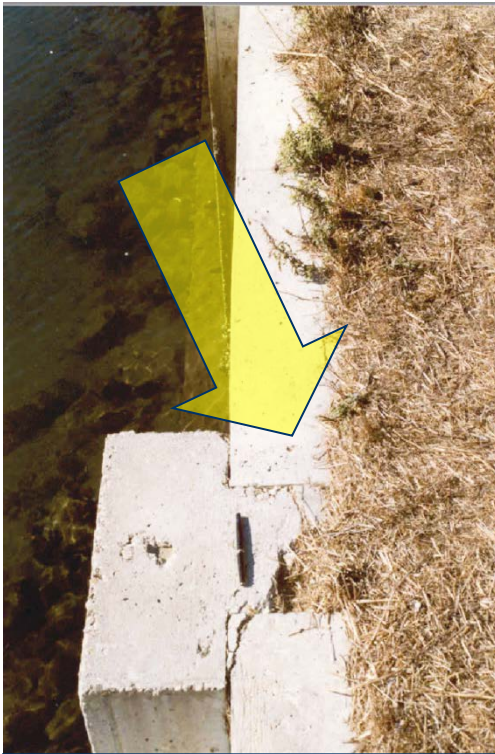
Small indication at surface

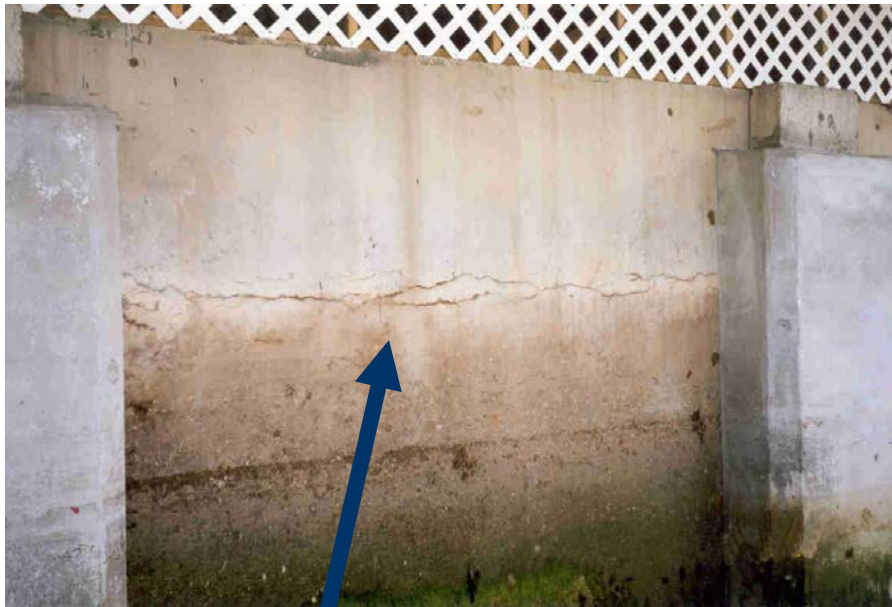
Typical Boise Wall panel crack

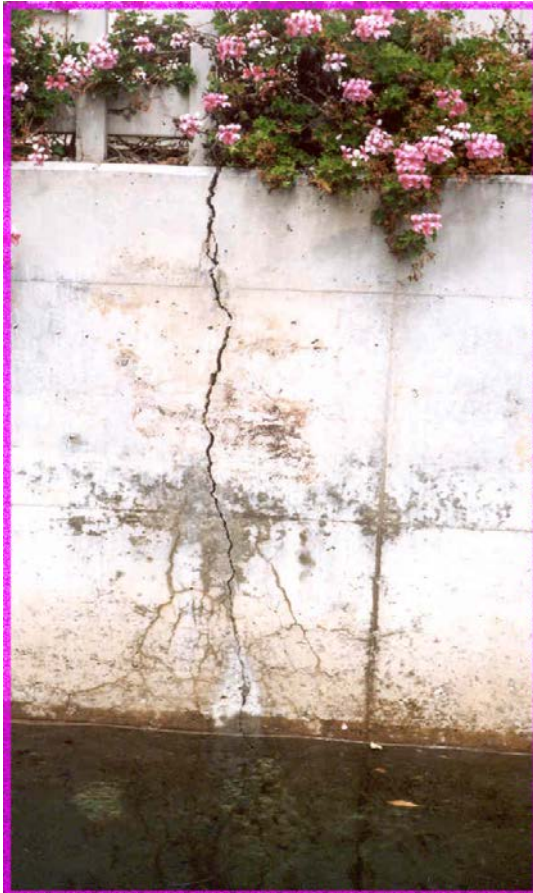
Before repair

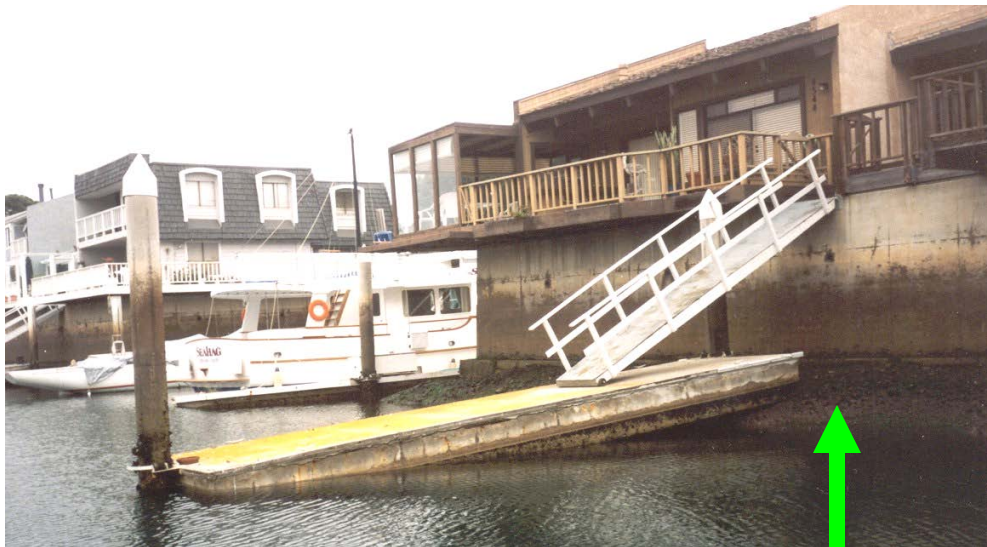
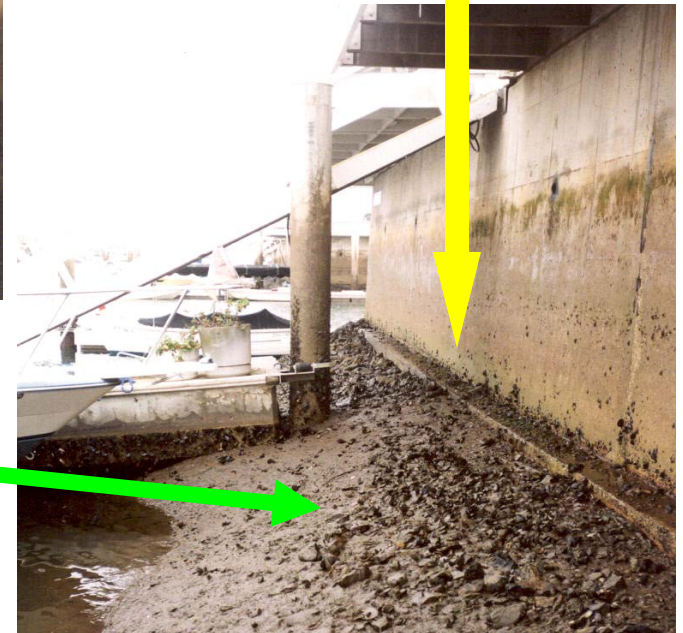
Cannot dredge deeper without undermining seawall foundation

Slope as originally built

Tides range between +7 to -2 Dec. - March two to three days each month. Up to 9 feet difference between high and low winter / spring tide.

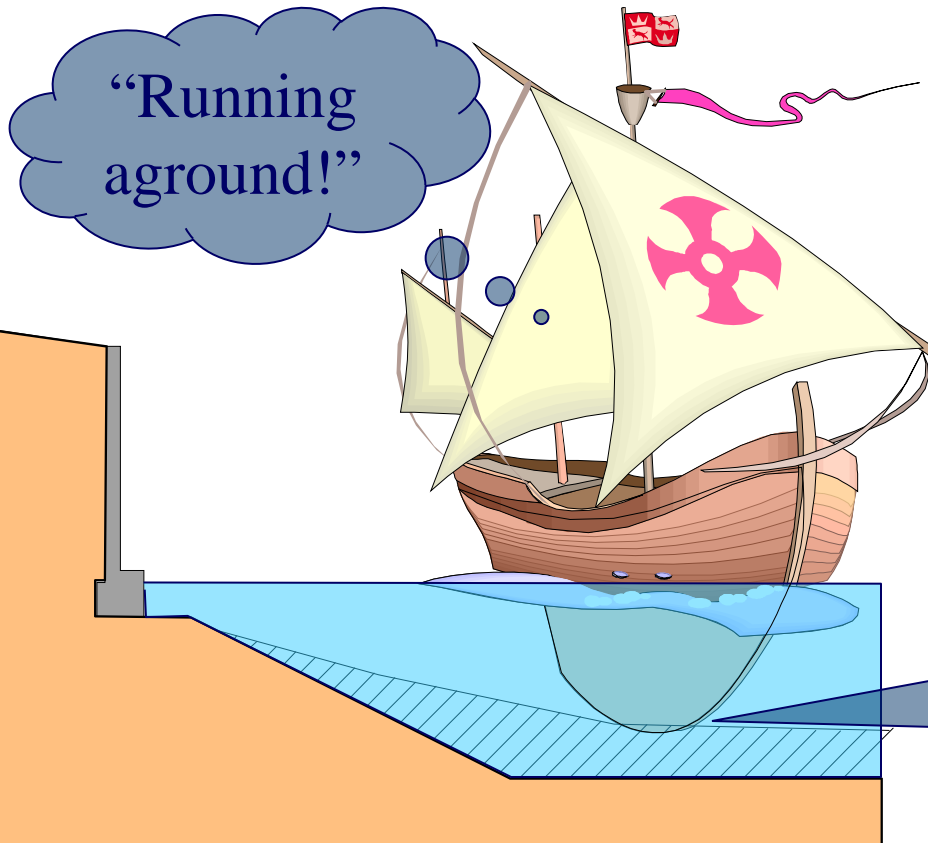
- ◆ Large draft
- ◆ Deep keels
- ◆ Low tide extremes

Boats with 6 FT or more draft can hit bottom

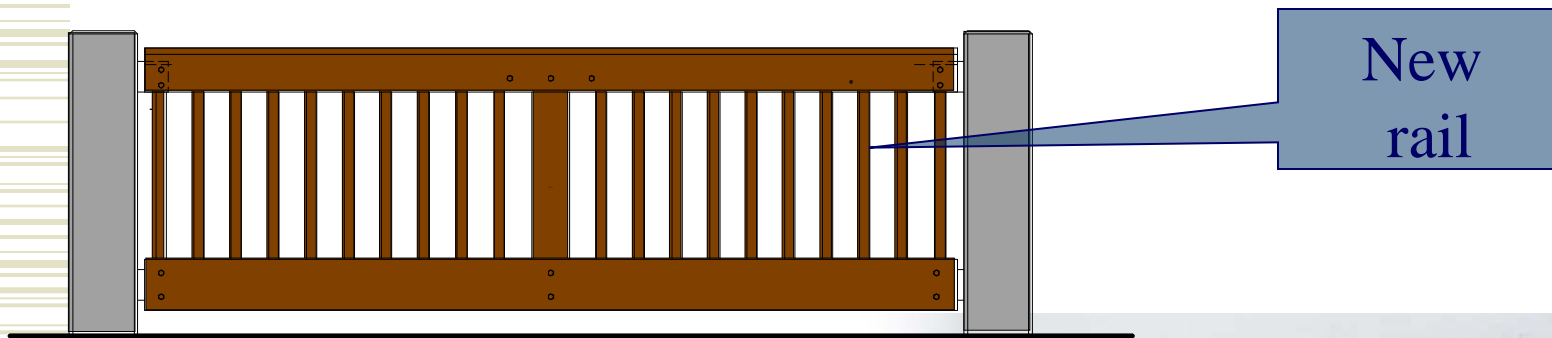
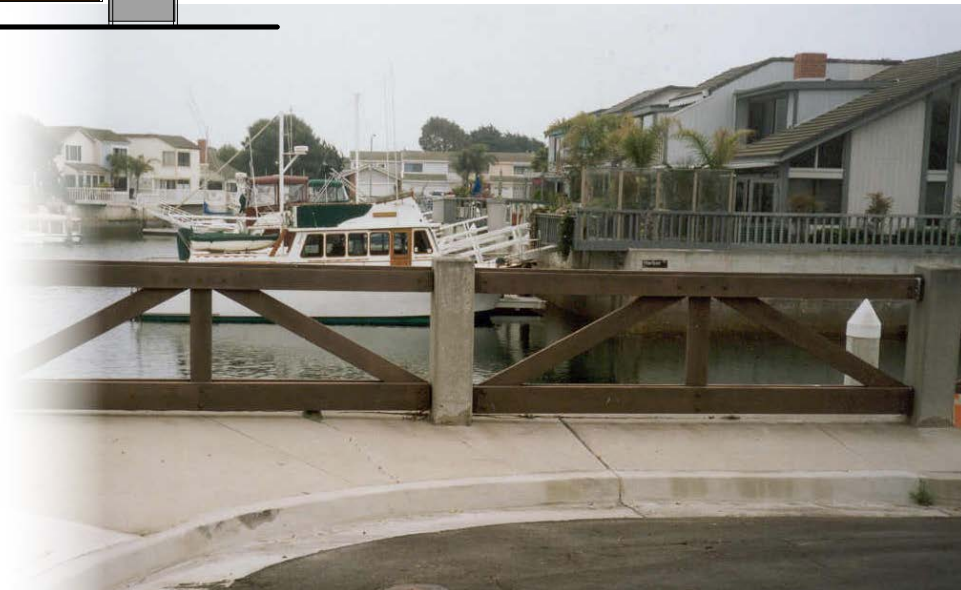
- ◆ Existing have termite & dry rot
- ◆ New rails will be treated wood
