# Public Works Department Streets & Waterways Division

## *Mandalay Bay Annual Report*

*Presented by*  
**Raymond Williams**  
**Construction & Maintenance Manager**

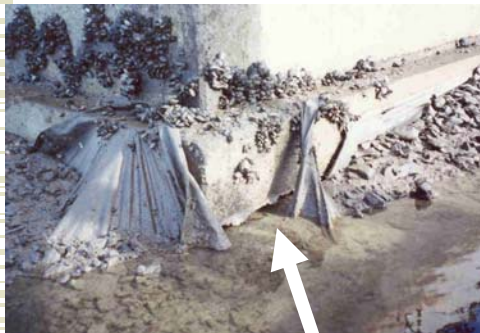
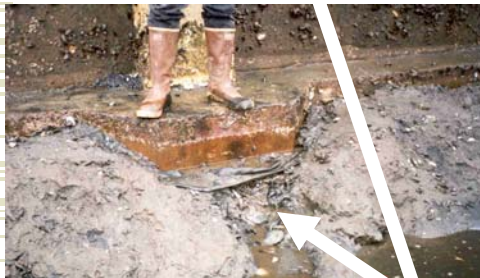
Bottom of foundation slab exposed

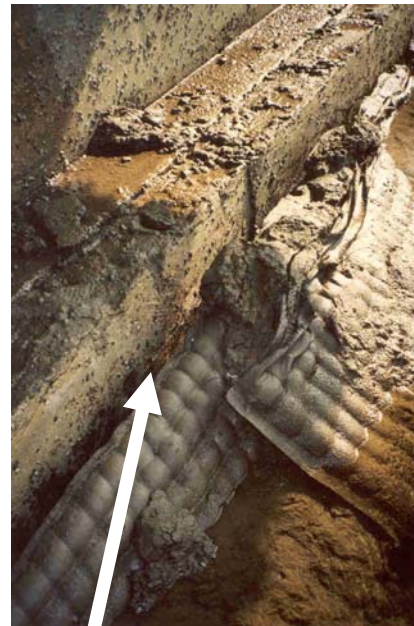
Hump in Fabriflex slope protection

Repair foundation area with polyvinyl sheet pile cutoff wall with concrete seal

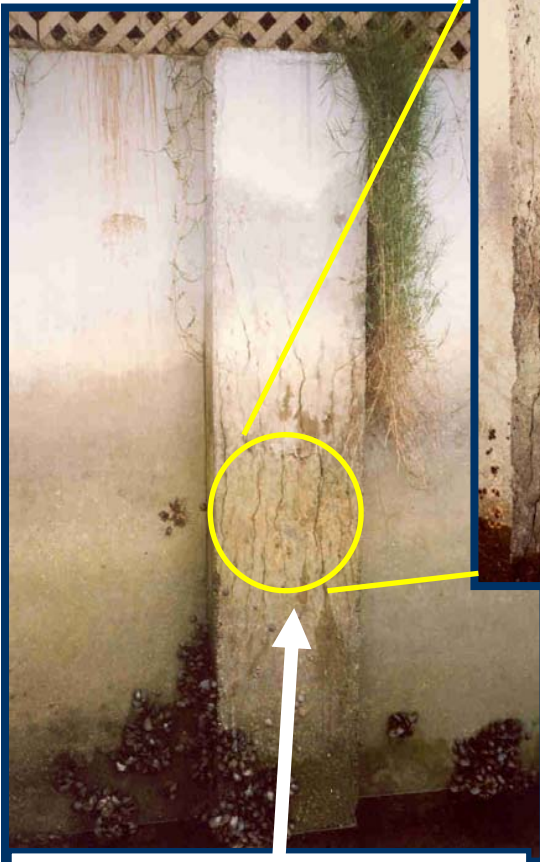
Typical deterioration

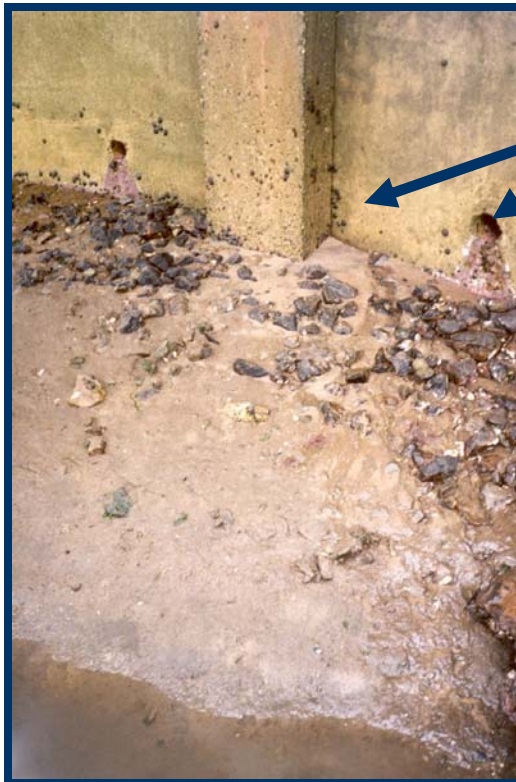
Backfill leaks from weep hole and gap between pilaster and wall panel

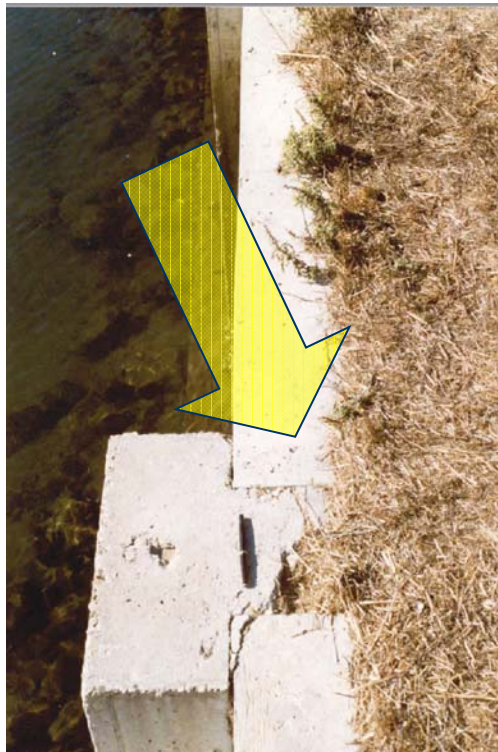
Small indication at surface

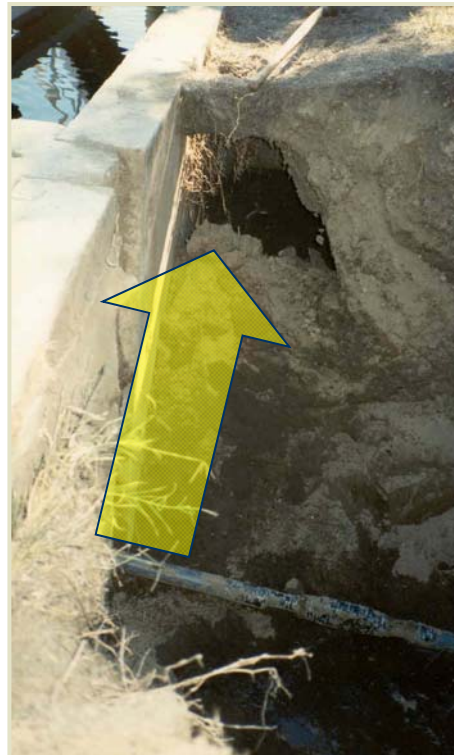
Excavate to uncover extent

Repair with sand/cement grout or gravel backfill

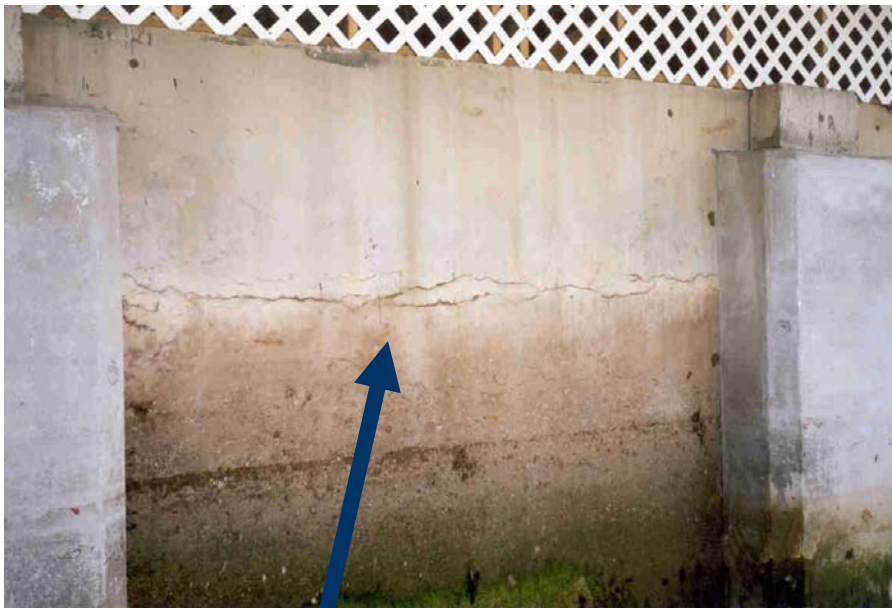
Typical Boise Wall panel crack

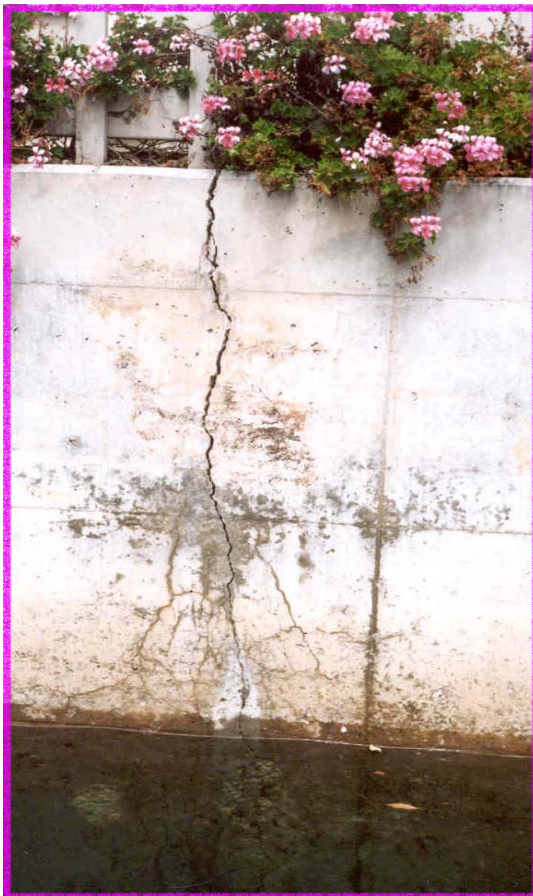
Before repair

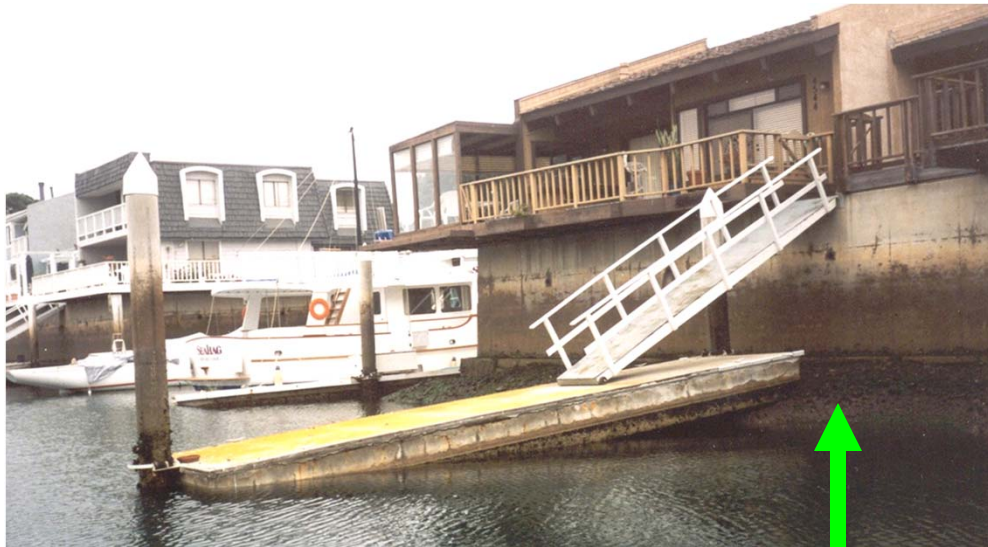
**Cannot dredge deeper  
without undermining  
seawall foundation**

Tides range between +7 to -2 Dec. - March  
two to three days each month. Up to 9 feet  
difference between high and low winter /  
spring tide.

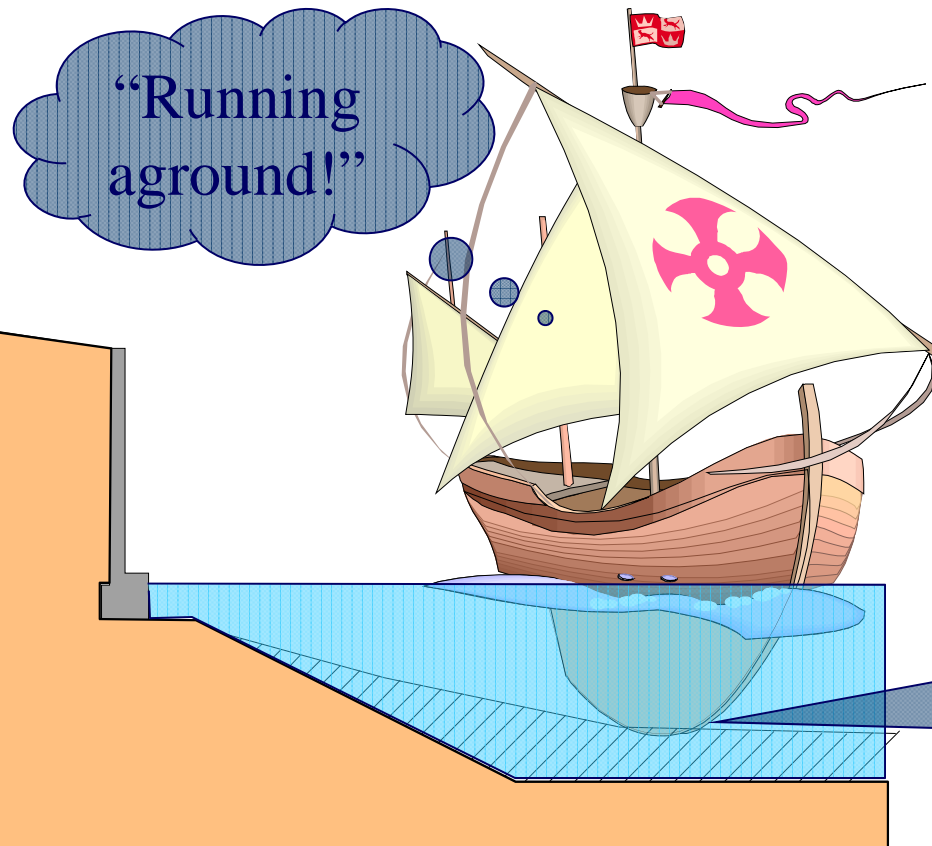
- ◆ Large draft
- ◆ Deep keels
- ◆ Low tide extremes

Boats with 6 FT or more draft can hit bottom

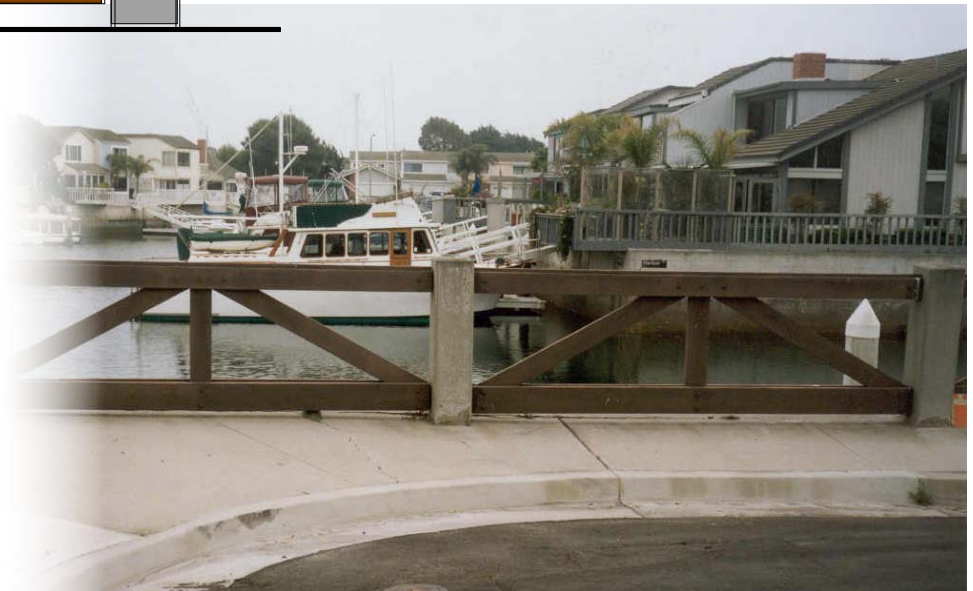
- ◆ Existing have termite & dry rot
- ◆ New rails will be treated wood

New  
rail
