# Seawall Maintenance & Repair 2016 CIWHA Annual Meeting

Eric Newman, PE – TranSystems  
Waterfront Civil Engineer

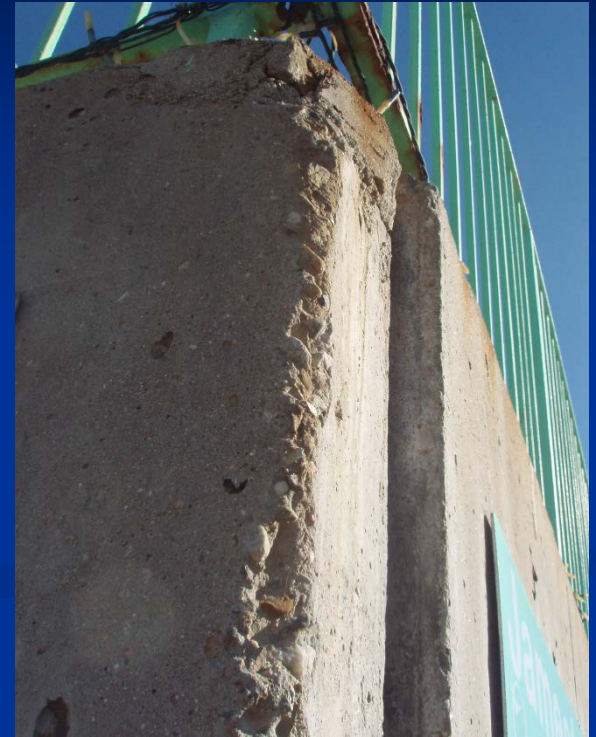
- Seawall Condition Assessment – Completed in 2012 (both above and below water)
- Developed repair alternatives and cost estimates for next 25 years of repairs needed to maintain the walls.
- Prioritized repairs from High Priority to Low Priority ranked on a scale of 1 Low to 5 High
- Seawall Monitoring Program – (10) seawall segments have suspected wall movement. Data points have been collected at 6-month intervals to determine if each segment is stable or movement is on-going and should be advanced to a High Priority repair.
