# Public Works Department Streets & Waterways Division

## *Mandalay Bay Annual Report*

*Presented by*  
**Raymond Williams**  
**Construction & Maintenance Manager**

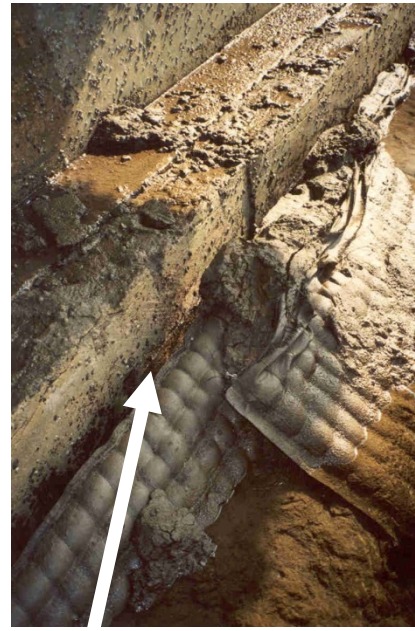
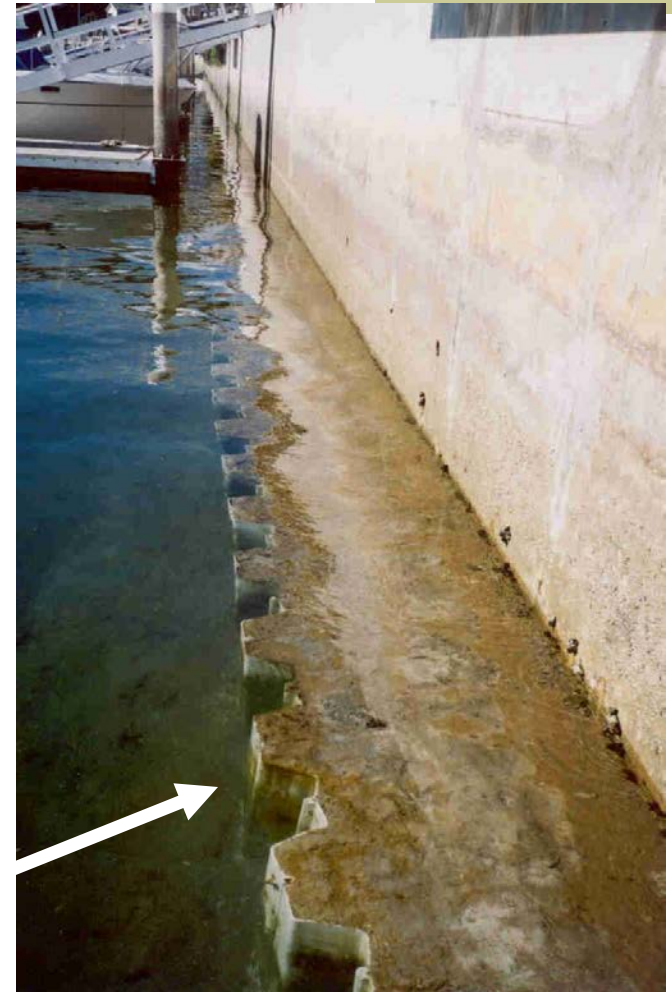
# Foundation & Slope Protection Repair

Bottom of foundation slab exposed

Hump in Fabriform slope protection

Repair foundation area with polyvinyl sheet pile cutoff wall with concrete seal

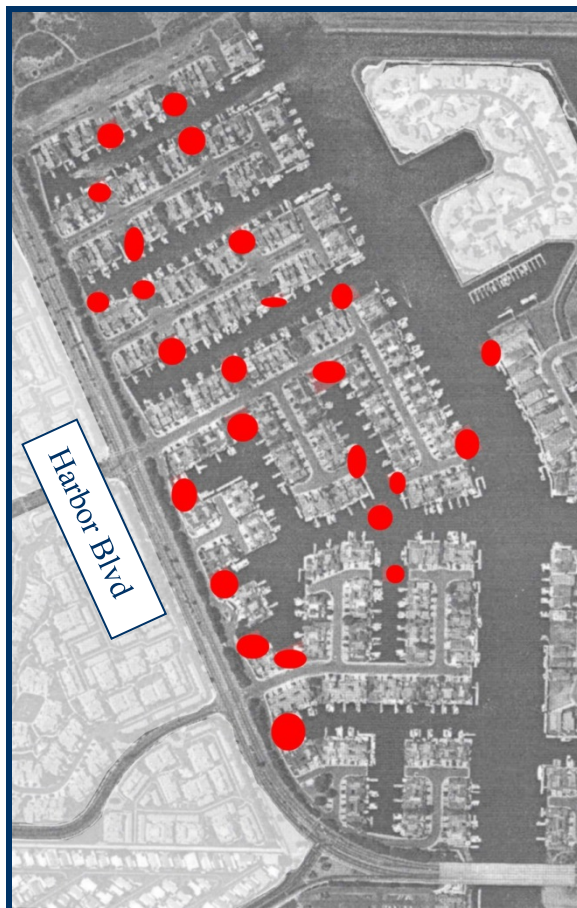
# Western Mandalay Bay

Approximately  
7,500 cubic yards of  
material in 25  
locations

Indicates location of  
shoal area

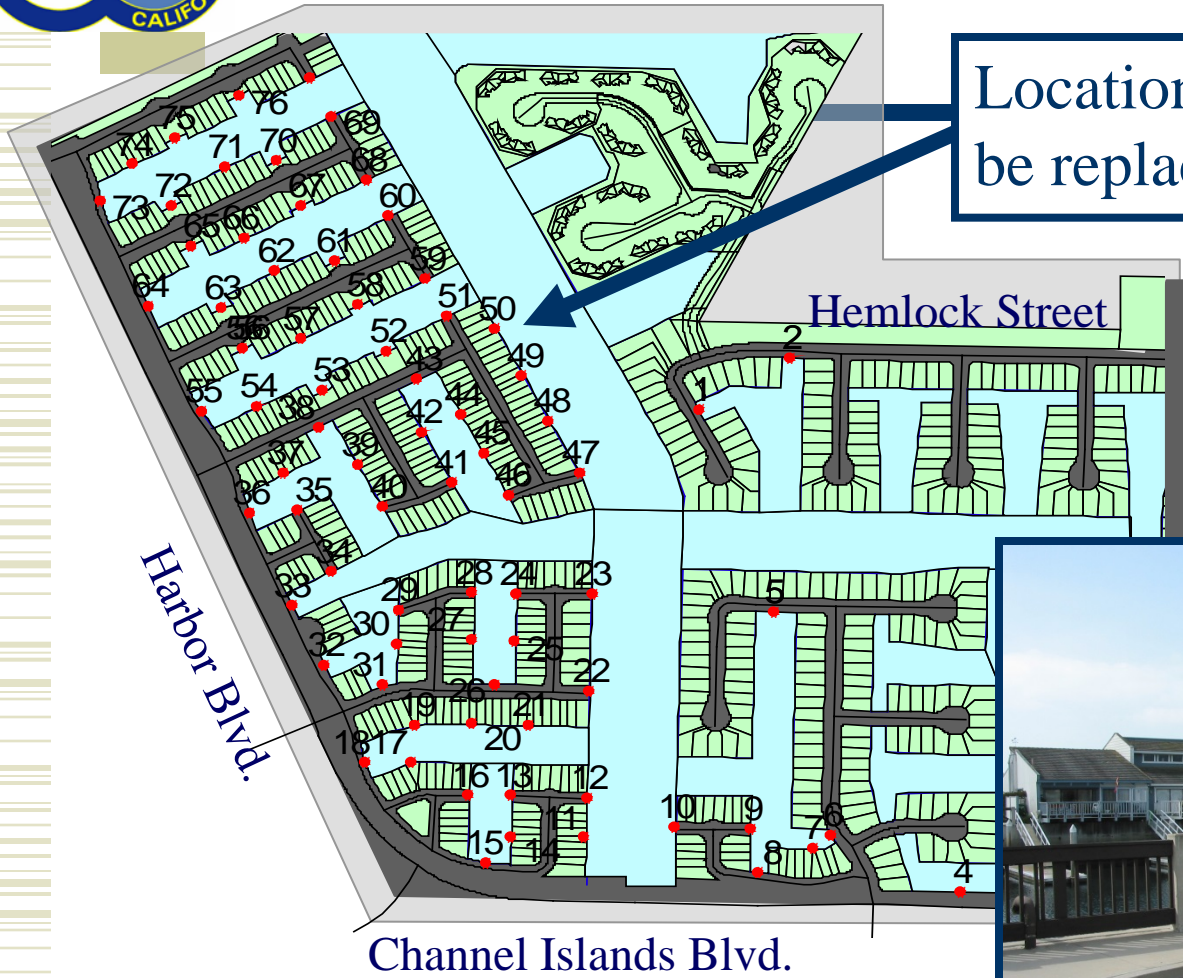
# Guardrail Replacement

- ◆ Existing have termite & dry rot
- ◆ New rails will be treated wood

Location of guardrail to be replaced
