Public Works Department
Streets and Waterways Division

Dock Repair and Replacement

Presented by
Jon Moore, PE
 Coastal Engineer
 Noble Consultants, Inc.

Mandalay Bay Docks

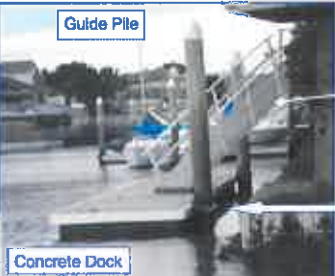
Pile Guide Detail

Guide Pile

Concrete Dock

Gangway
